Additional Pictures to: Process Induced Defects in Si Chips

Part 1 Pictures in the Report and Publication

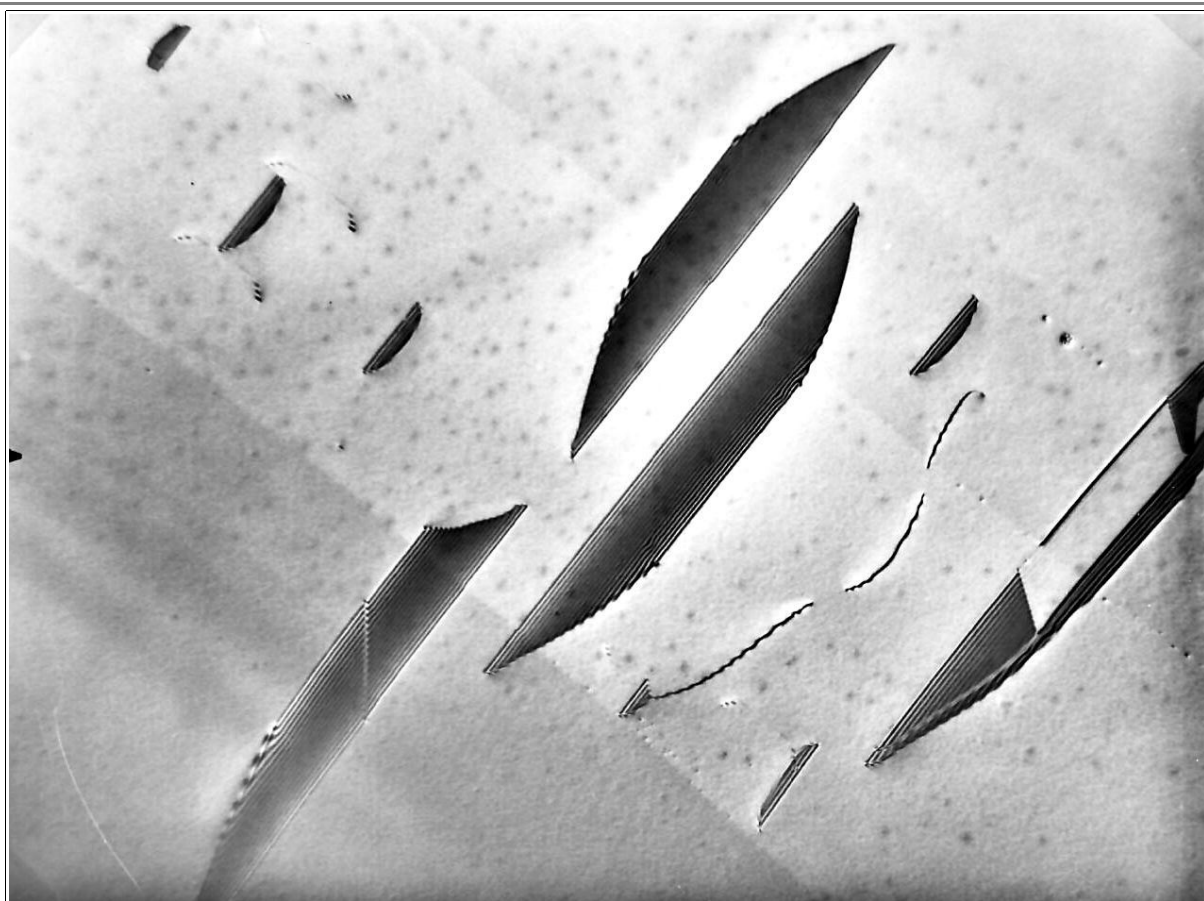
Many of the defect structures found have never seen before. In some cases we simply did not know what we witnessed. It took involved contrast analysis and some cunning to figure out what has happened. It is hard today to imagine the excitement one experienced seeing some of these things for the first time.

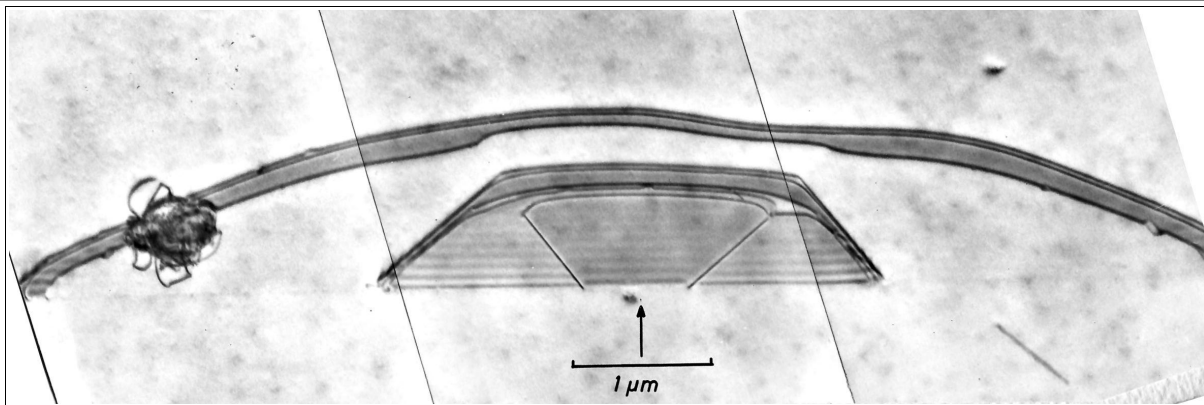
Fig. 14 b in report; Fig. 3b in publication..

Fig.3 (a) Stacking fault network, (b) nine-fold stacking fault.

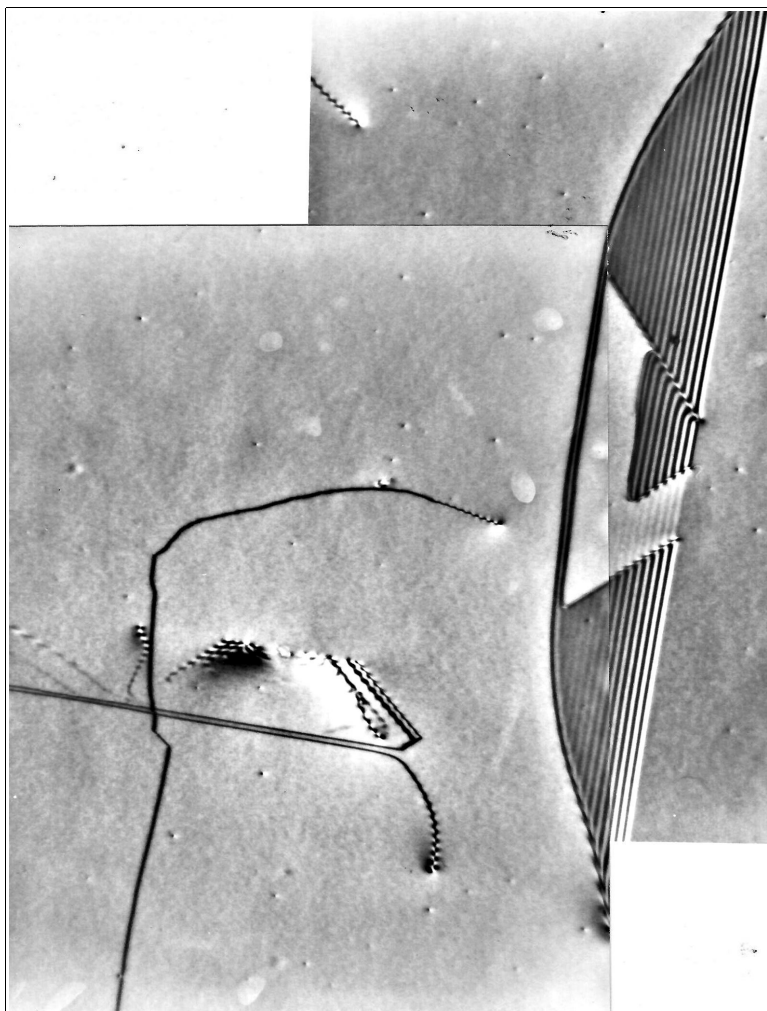
Auxiliary picture.

Multiple stacking fault from above out of contrast
plus another one (in contrast) at the side.

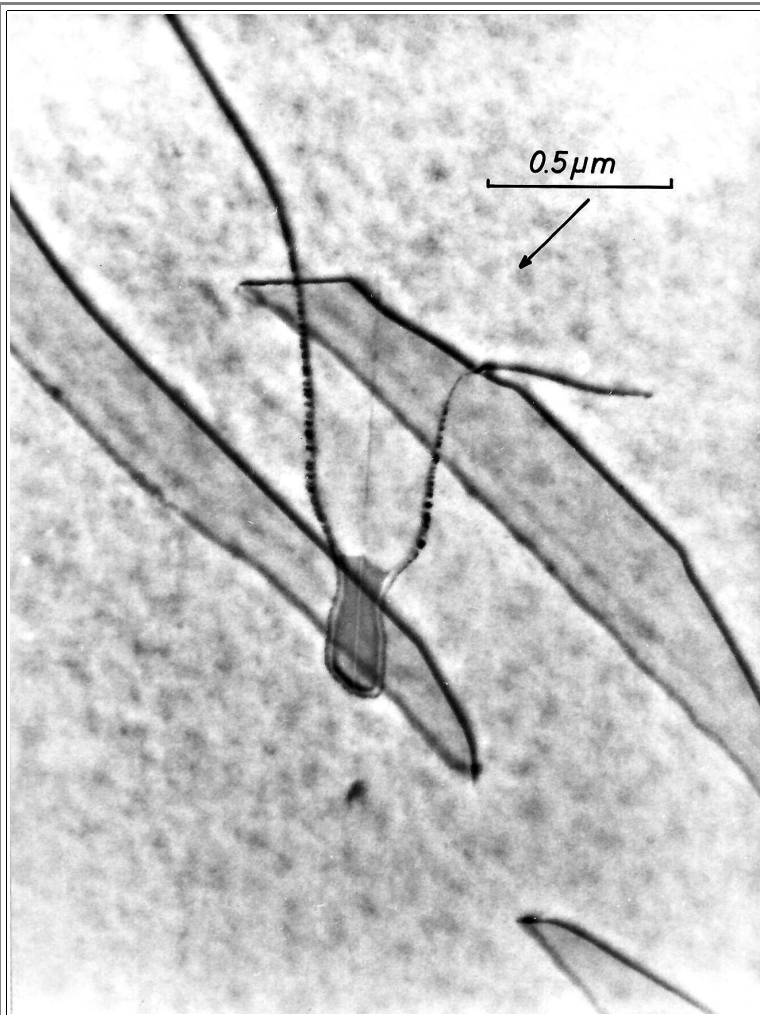
Fig. 19a) in report; Fig. 6 in publication.

Fig.6 Typical example of an unfaulted sailing boat SF.

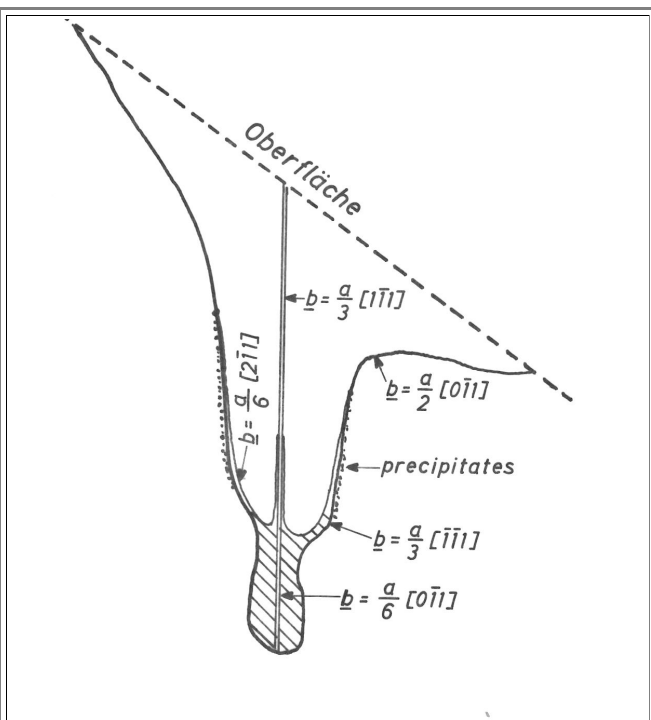
Fig. 19b) in report; Fig. 7a) in publication

Fig.7 (a) Sailing boat stacking fault after an unfaulting reaction.
(b) Schematical drawing of its crystallographic structure. (below)

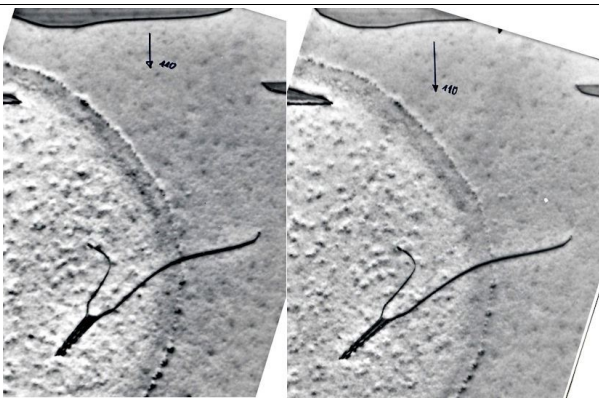
Fig. 19c) in report; Fig. 7b) in publication.

This fellow combines all possible kinds of dislocations in Si plus a stacking fault.
The unfaulting reactions is rarely seen "in-situ".
