# Additional Pictures to: Process Induced Defects in Si Chips

## Part 2 Auxiliary Pictures 1

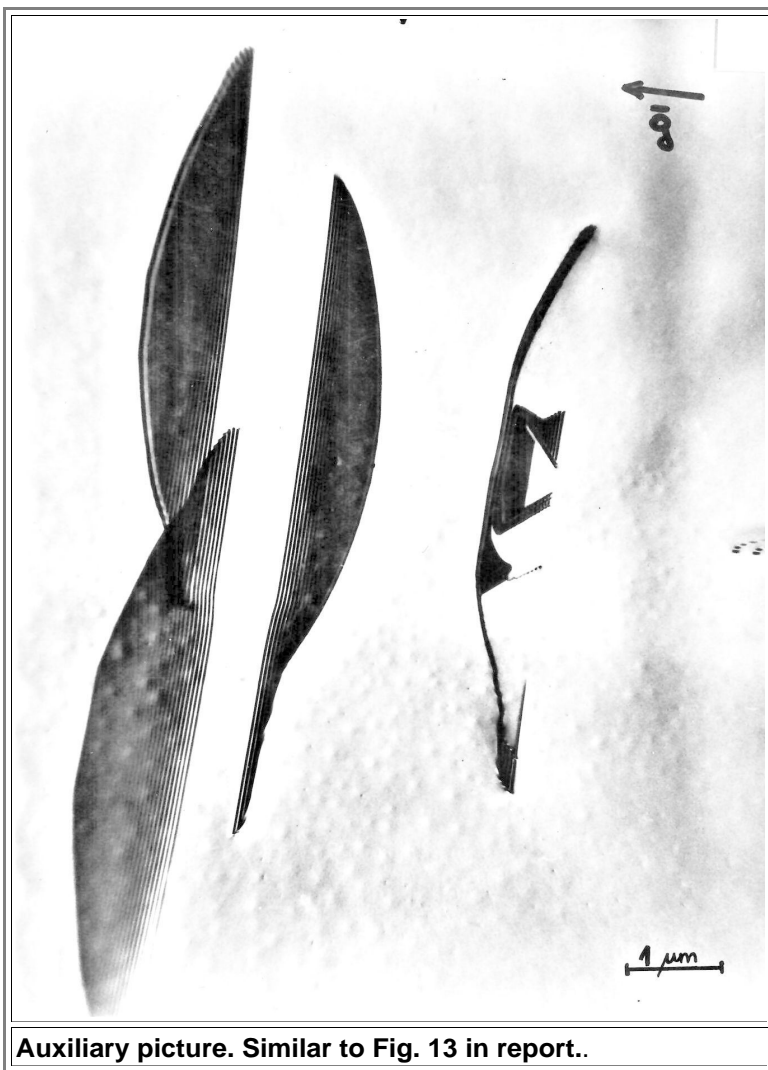
Auxiliary picture. Similar to Fig. 13 in report..

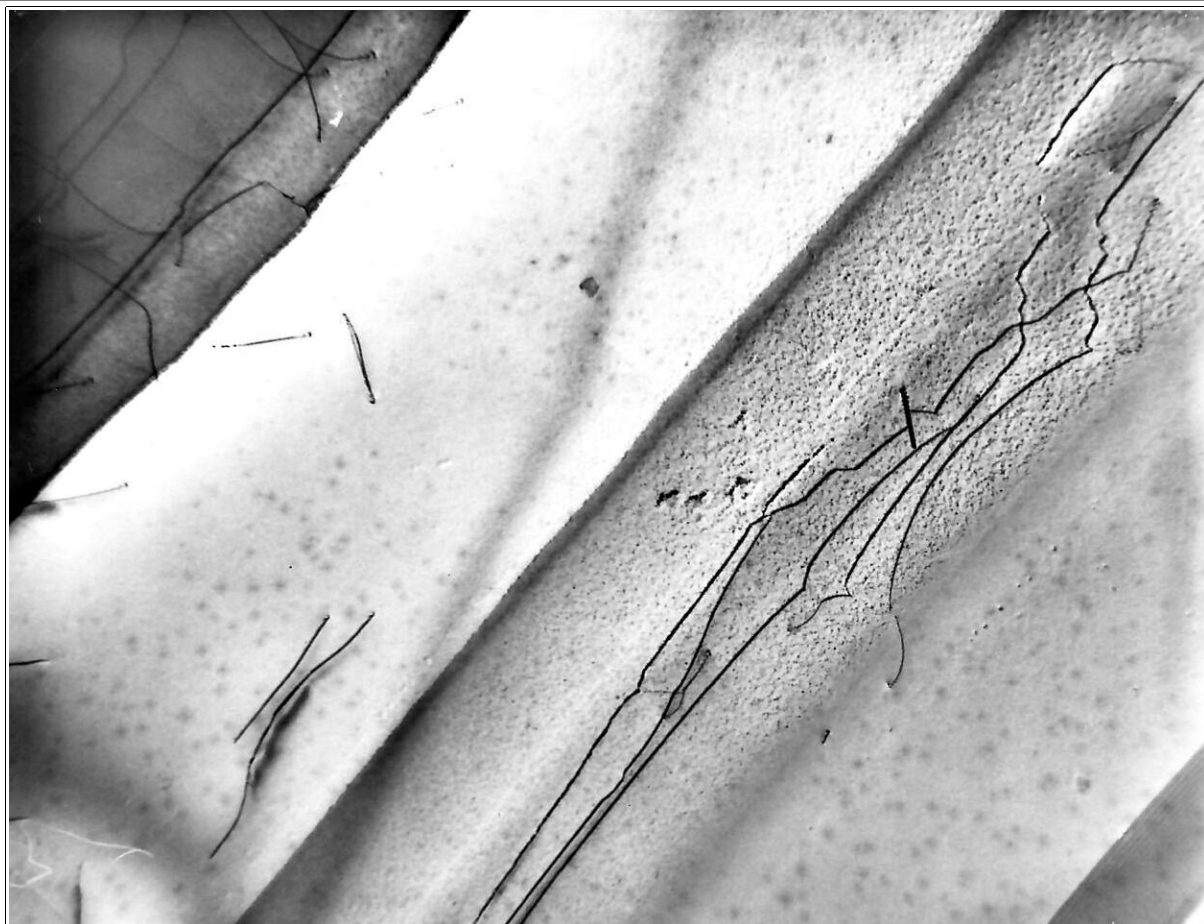
Auxiliary picture. Same sample as Fig. 13 in report.

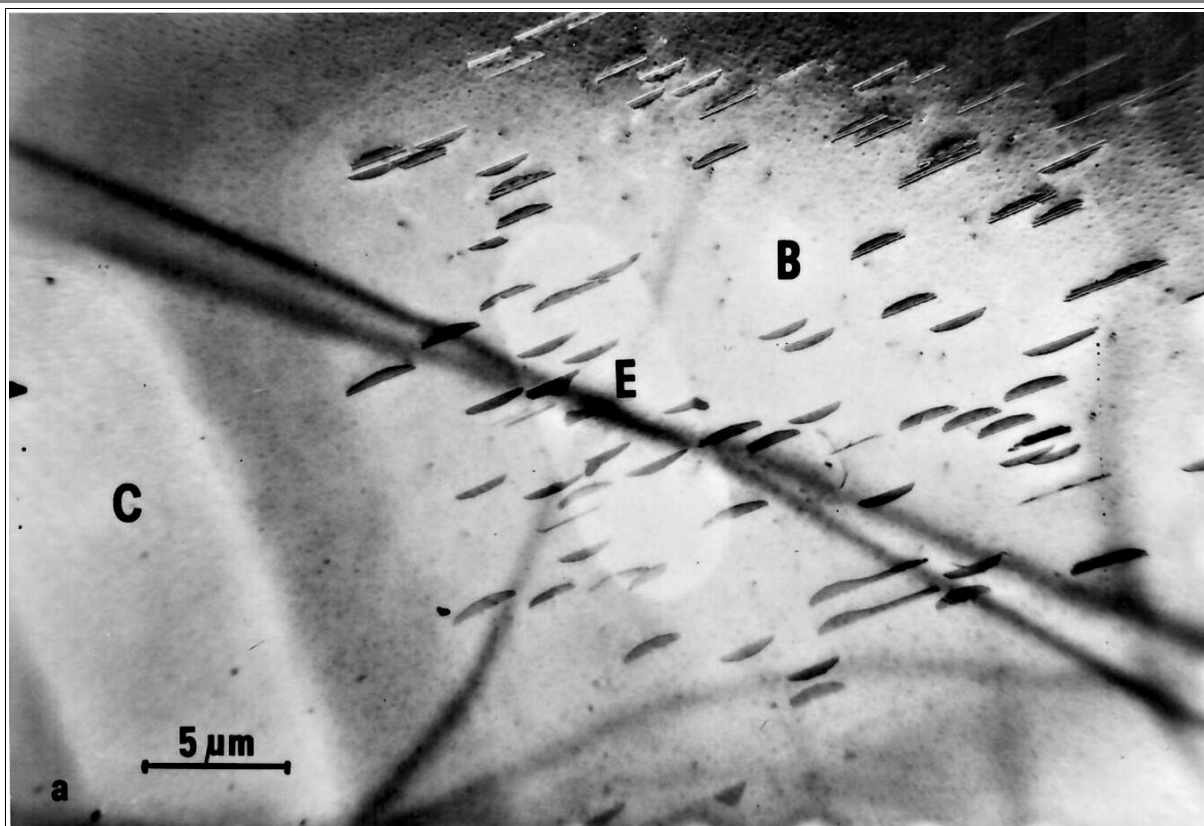
Auxiliary picture. Similar to Fig. 18 in the report and Fig. 5 in the publication.  
Small stacking faults only in the emitter region, Only one of two types is visible

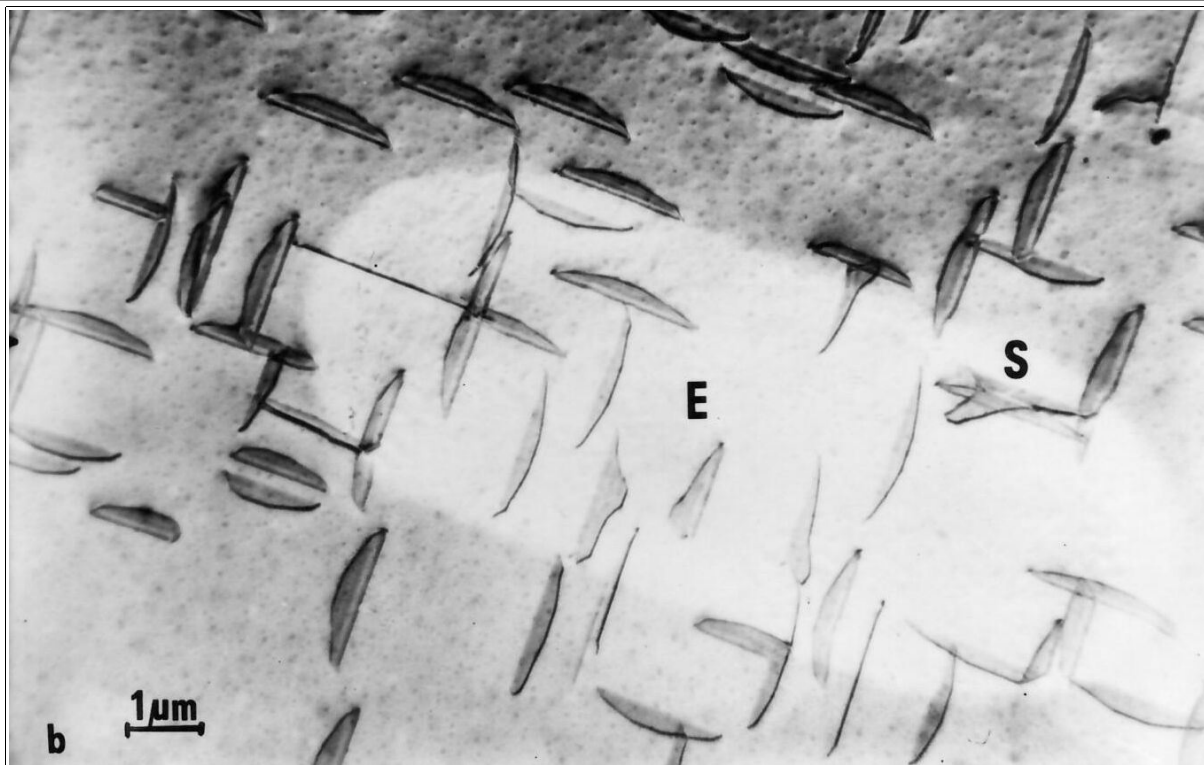
**Auxiliary picture. Similar to Fig. 18 in the report and Fig. 5 publication; as above.**  
 Small stacking faults only in the emitter region, Both types are visible, including a "sailing boat" stacking fault

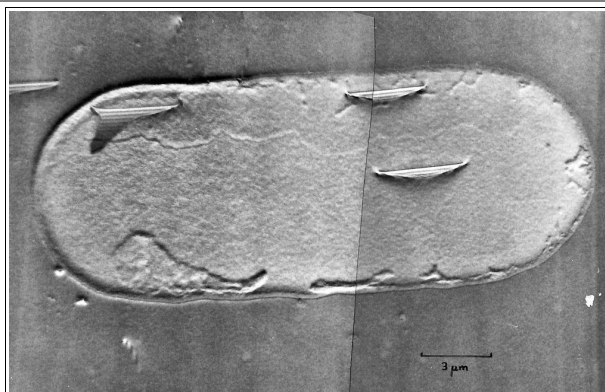
**Auxiliary picture. Similar to Fig. 18 in the report and Fig. 5 publication; as above.**  
 There is a deadly "sailing boat" stacking fault in the emitter

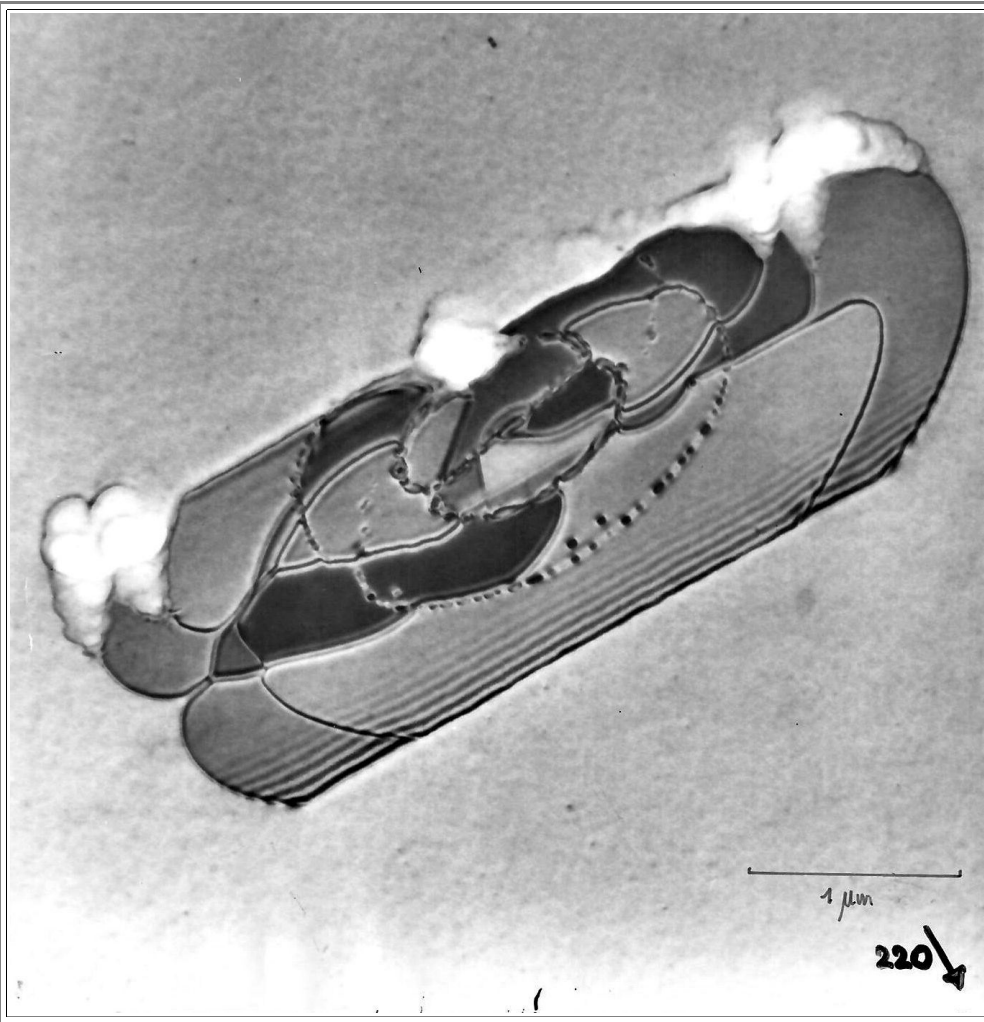
**Auxiliary picture. Similar to Fig. 54 in Report..**

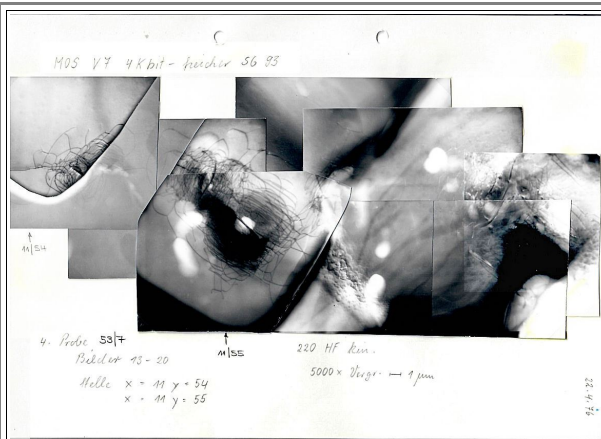
**Auxiliary picture .Relates to Fig. 50 uin the report and Fig. 2a) in the publication.**

This is a page from our documentation records. It also illustrates the problems with the very high contrast due to thickness variations and how much work was necessary in the dark room to come up with a composite like this.

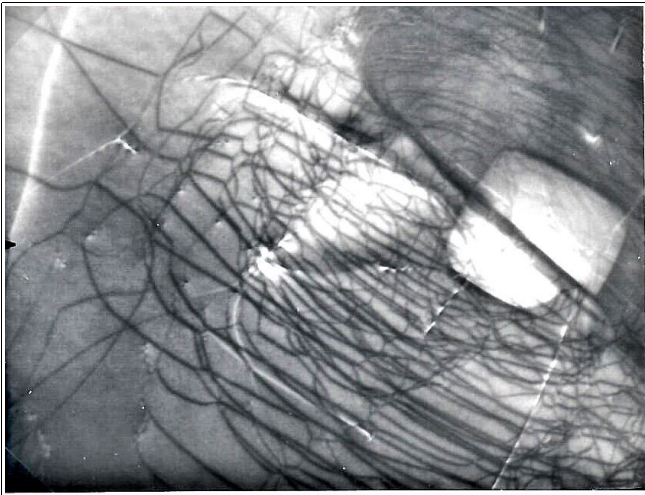
21

1. Probe

220 HF kin.

$x = 11$   $y = 55$  Zentrum

14 000  $\times$  Vergr.

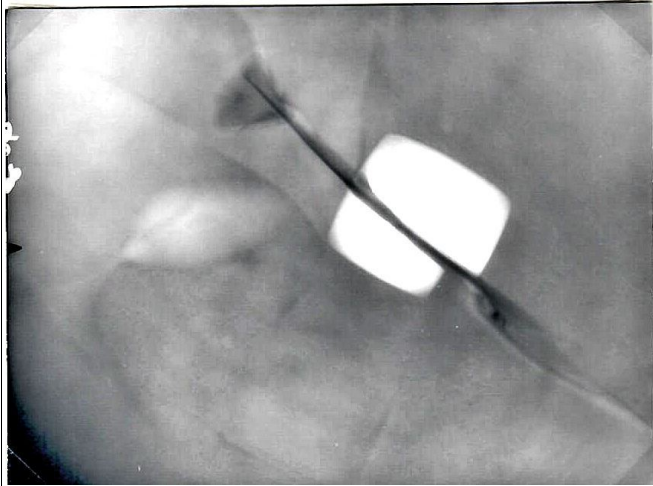
22

2. 220 HF kin.

14 000  $\times$  Vergr.

Reflex nicht richtig angeregt

Auxiliary picture. Details to the picture above.

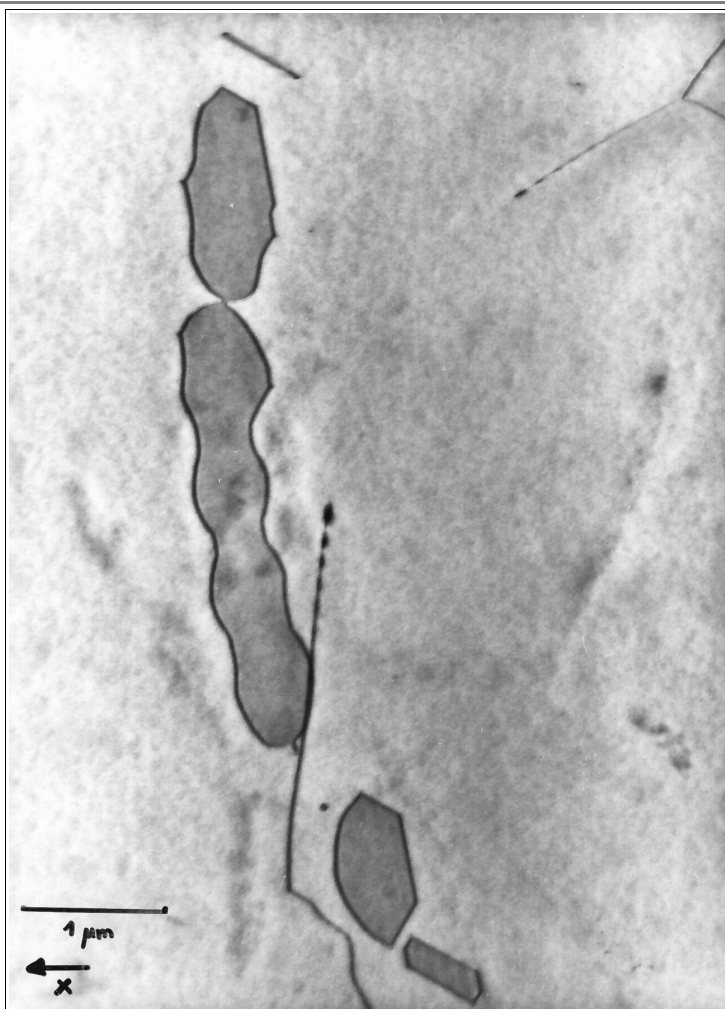
**Auxiliary picture.**

Illustrating what an excess of point defects (l.e. interstitials from oxidation) plus stress can do if there is some nucleation..

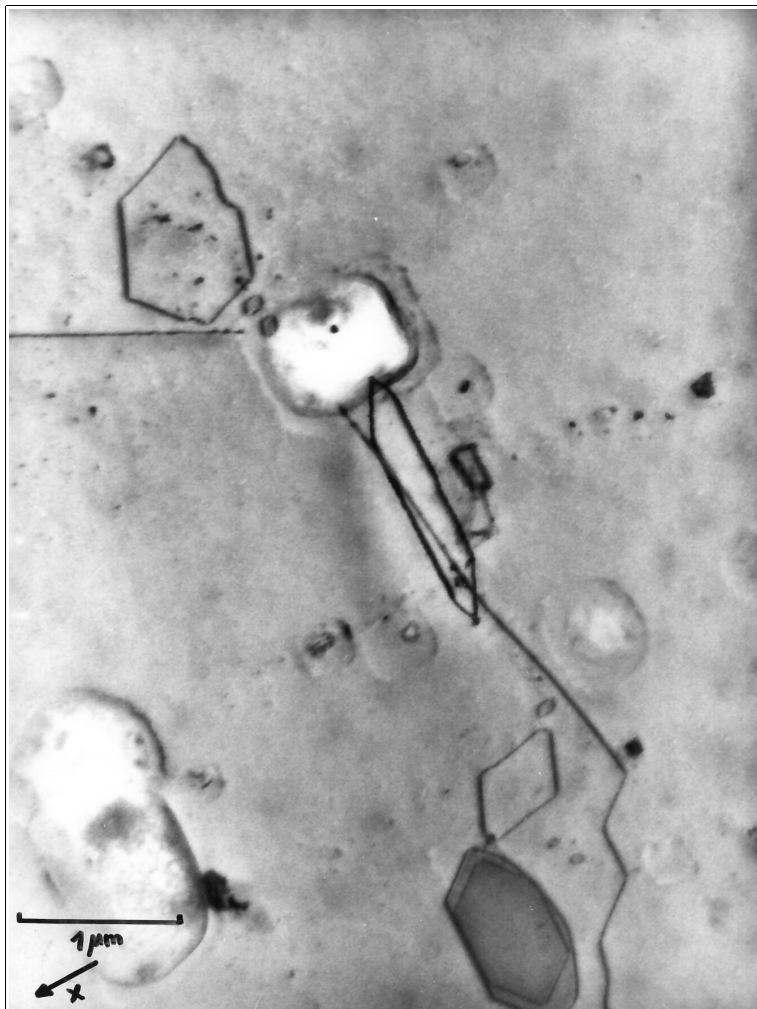
**Auxiliary picture. .**

Same as above

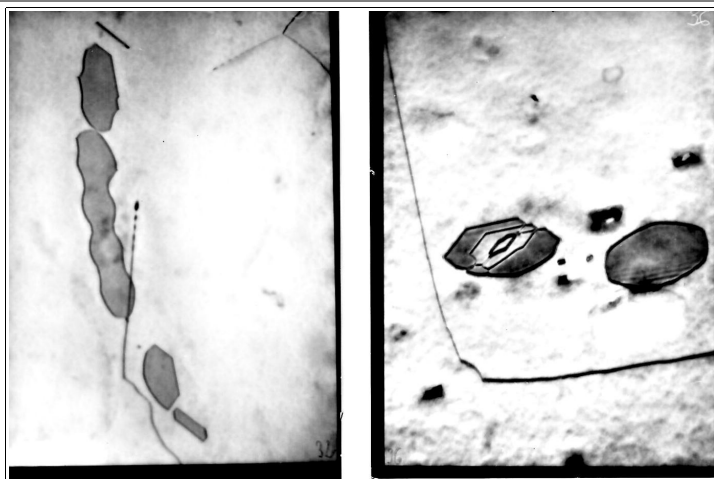
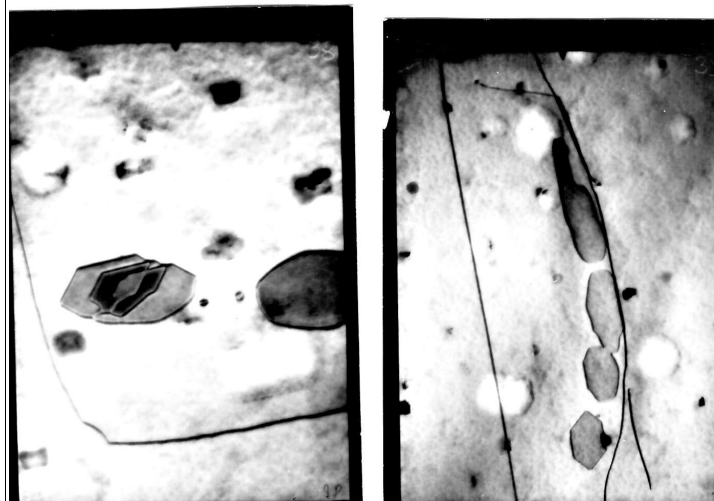
**Auxiliary picture. .**  
Same as above. Page from our "scrap book"

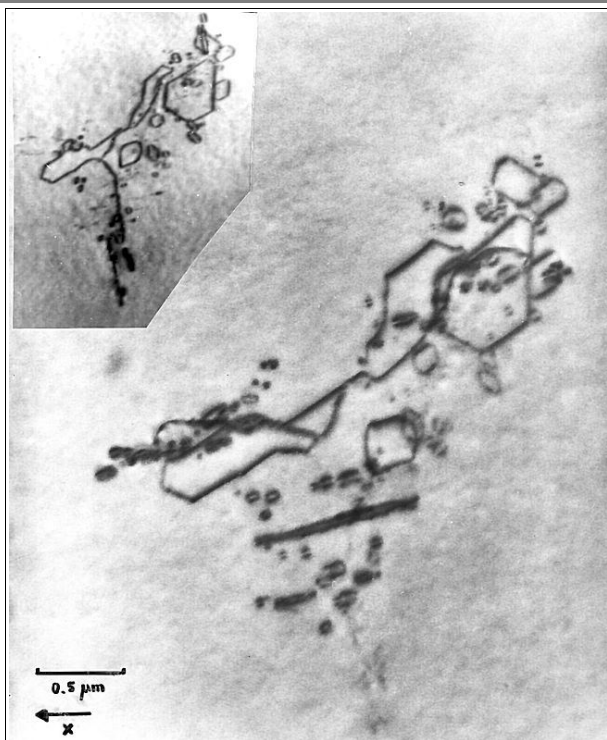
**Auxiliary picture. .**

Same as above. Probably metal precipitates.  
Illustrating that ultimately nucleation controls almost everything and that the nuclei are often if not always small metal precipitates.  
The inset shows the cluster under different diffraction conditions.
