## Pictures to: 2.3 Swirl Defects in Si (Investigated in a HVTEM)

### Part 1

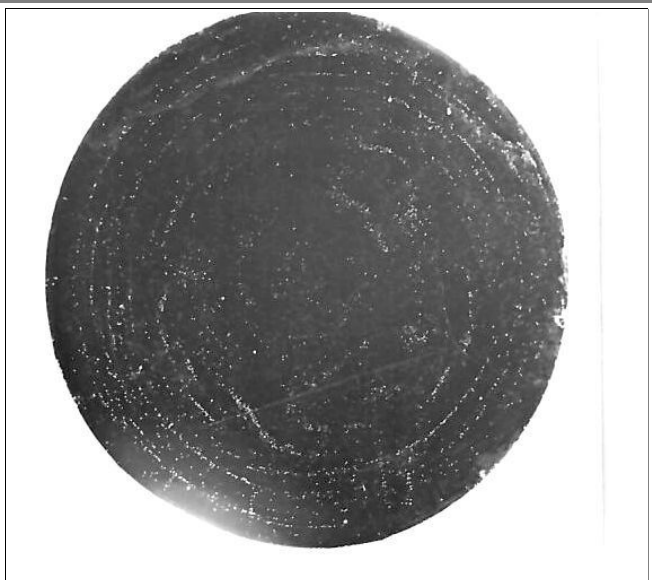
Etch pattern of swirl defects on a 33 mm float-zone (FZ) Si crystal; somewhat less showy than the one above..

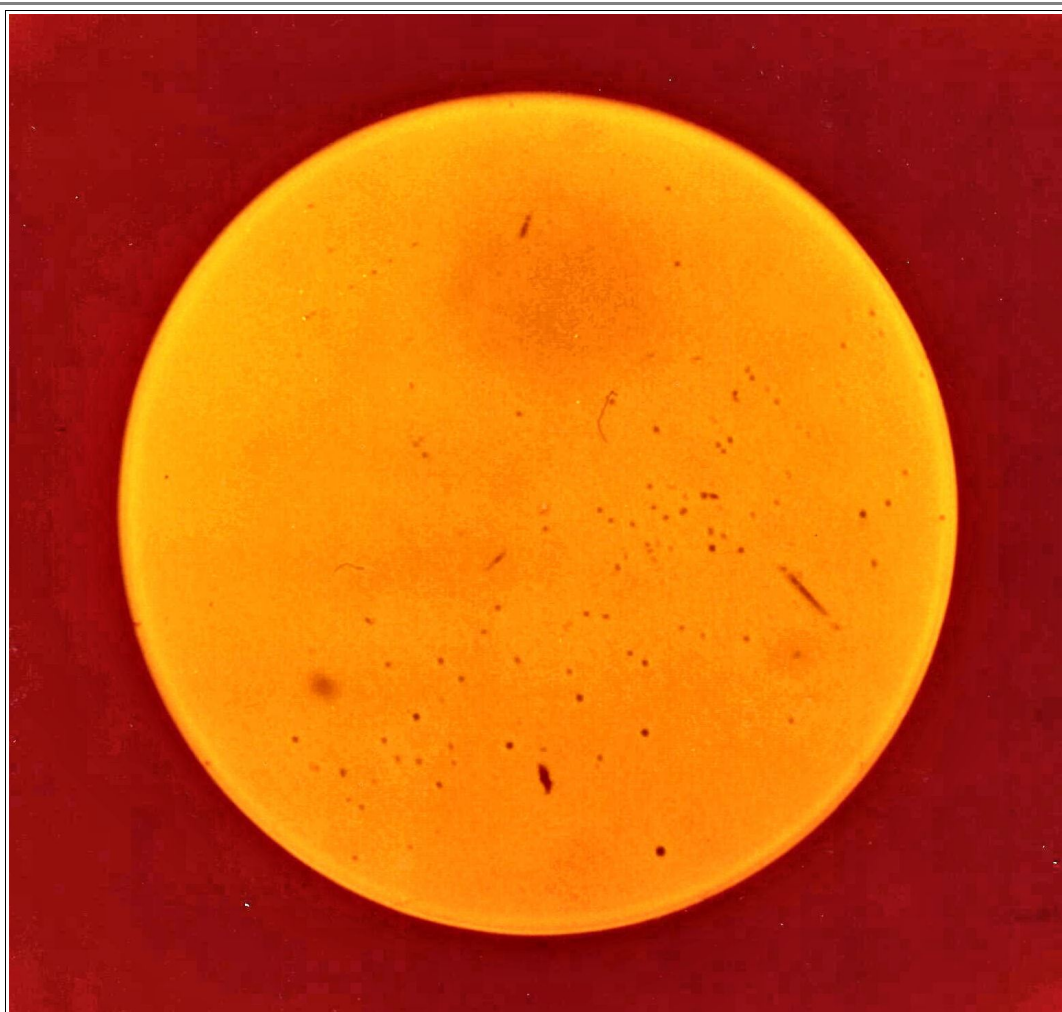
**Specimen ready for HVTEM inspection. Seen in an optical microscope using through-light..**

The diameter is around 2.3 mm. The thickness of the specimens is around 5  $\mu\text{m}$  and at this thickness Si becomes transparent.

With a HVTEM the whole specimen is transparent (if barely) to the electron beam.

A normally prepared specimen would only have a small fraction of the whole area transparent to the beam.

The A-swirls are visible as darker spots since the thickness is larger at the hillocks. Finding one in the HVTEM still could take a long time
