F14
ptk. caPLANAR DEFECTS IN SILICONProgress Report

H. Föll

D. Ast

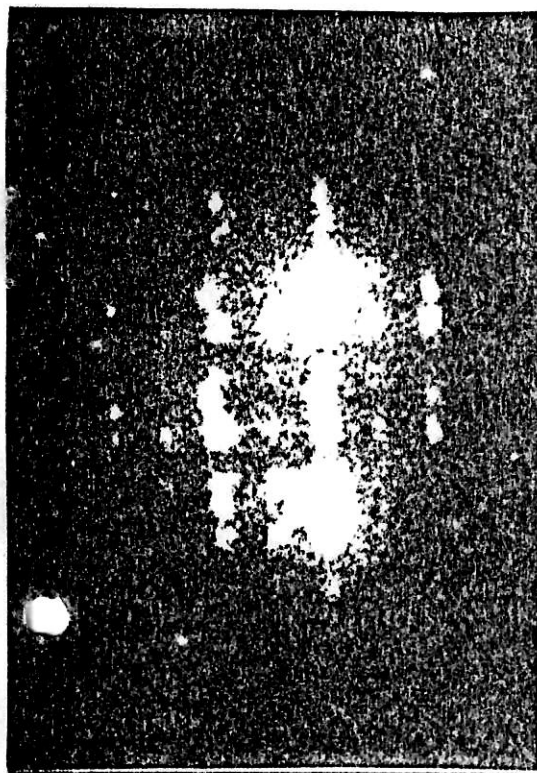
Fig. 3 Lattice fringe image of screw dislocations in a low-angle twist boundary on $\{100\}$. Only one set of dislocations shows up.

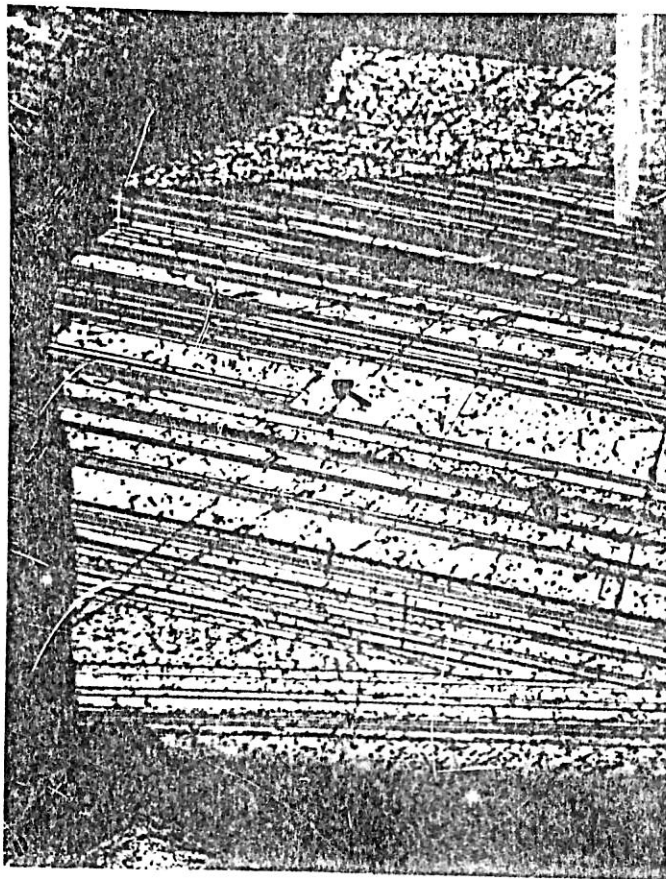
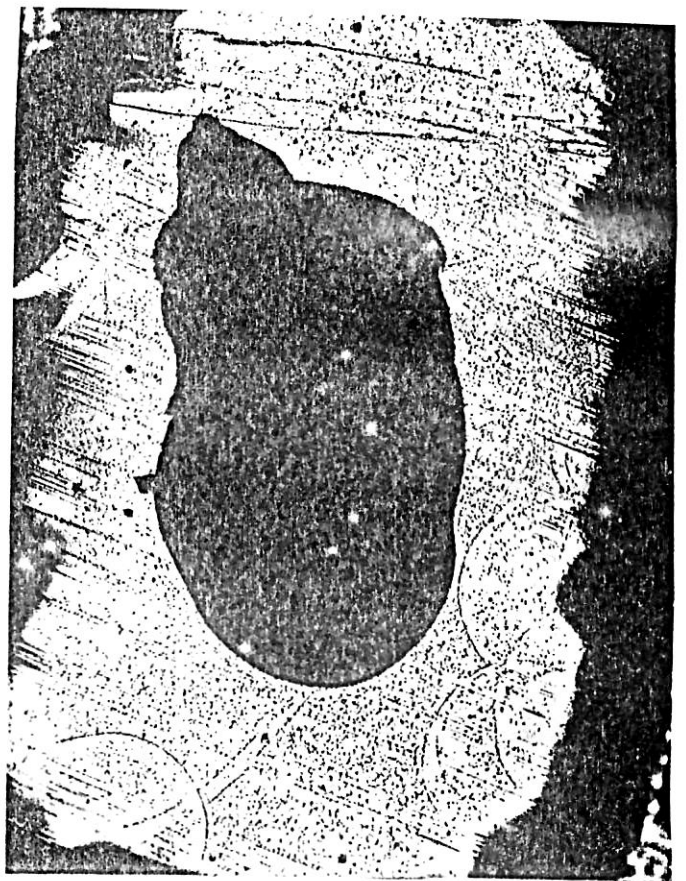
Fig. 6

- a) Etch pattern before thinning
 b) Etch pattern after thinning
 c) TEM micrograph showing incoherent twin boundaries and coherent twin boundaries (marked with arrow)
- Defect marked with arrow

by either chemically thinning with a "slow" solution or by ion-milling under optical control. The final stage is arrived when the edge of the hole cuts through the defect. Figure 6 shows a specimen before and after thinning; it can be seen that the interesting defect (the "wedge" within the twin boundaries) is partially contained within the thin specimen areas near the edge of the hole. TEM investigations then demonstrated that the "wedge" is formed by a number of wavyly faceted incoherent twin boundaries on mainly $\{112\}$ planes. Other defects detailedly characterized with this technique are microtwins ending in the specimen and secondary twins. After the "calibration" of the etching features by TEM is completed it is hoped to identify certain defects only by etching.

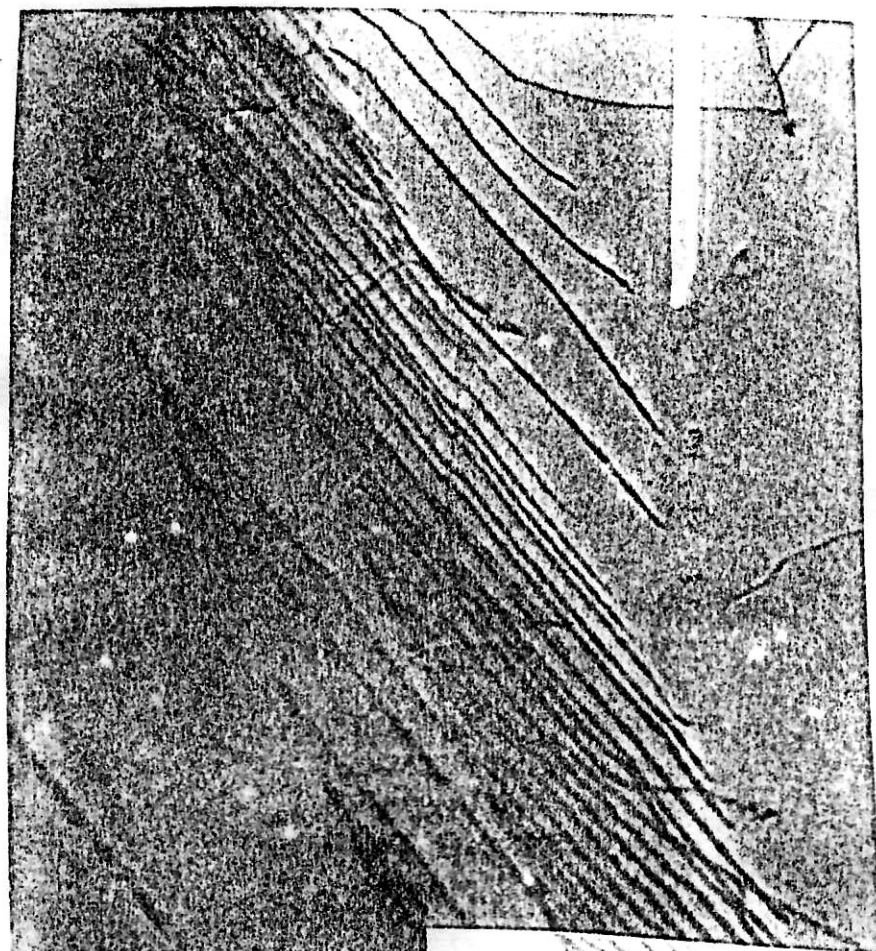
Fig. 12

Dislocation array
(= low angle grain
boundary) in Si
ribbon
