Defects in Transistors Revealed by Etching

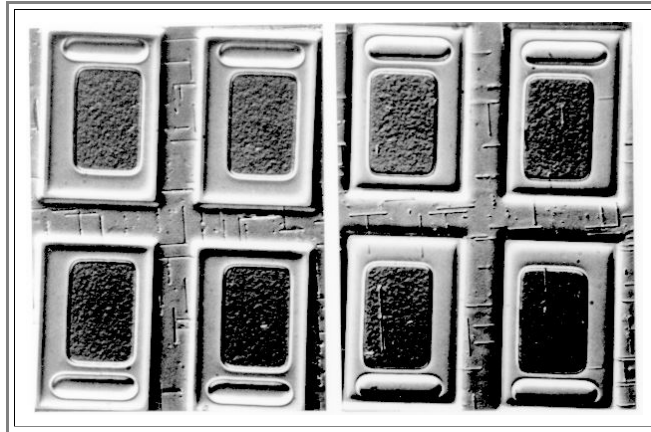
Stacking faults revealed by the so-called "**Secco etch**" for **30** seconds in transistors. For one kind of process we can see different phases of the stacking fault generation by process-induced "forces" by looking at wafers from different stages of the process:

Here we see bipolar transistors where just the collector contact (the oval part) and the base region (the rectangular part) have been defined. We have:

- Small stacking faults only outside the transistor areas (the rectangles) on the left-hand side
- Large stacking faults inside and outside the transistors on the right-hand side. These stacking faults may actually be rather complicated structures [akin to the one shown in the backbone text](#).

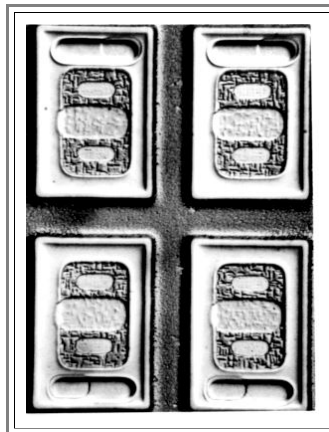
Now we have progressed to the emitter (the two smaller ovals) the base contact (the bigger oval) and the highly doped contact area of the collector (the small oval in the bigger collector contact oval)

- We have small stacking faults in high density only in the base region (including the contact). The others either vanished (unlikely) or were not produced in this wafer.
- What that looks like at [high magnifications](#) as seen by transmission electron microscopy can be seen in the link.

The question is: Will the transistors work? The answer is: It depends.

- The transistors without any stacking faults will work, but their leakage currents may still be considerably higher than the leakage currents in transistors without any stacking faults in the neighborhood.
- The transistor with large stacking faults in their interior will most likely not work at all. They will have a short-circuited emitter-base diode.
- The transistors with small stacking faults will mostly work, (albeit not too well), but some of them will be dead. The likelihood of "death by stacking fault" increases with the stacking fault density. This puzzle [could be solved](#) by **TEM**.

We also can see that the alignment of the structures to the $\langle 110 \rangle$ direction of the wafer is rather poor (the rectangles are not parallel to the traces of the stacking faults) and the alignment of the structures is not too good either (the base contact, e.g., is not at the exact center of the base).
