## Pictures to: 2.3 Swirl Defects in Si (Investigated in a HVTEM)

### Part 3

Months after I thought I was done with archiving the swirl work, I found another file full of pictures not yet selected. Here is a small number of these finds.

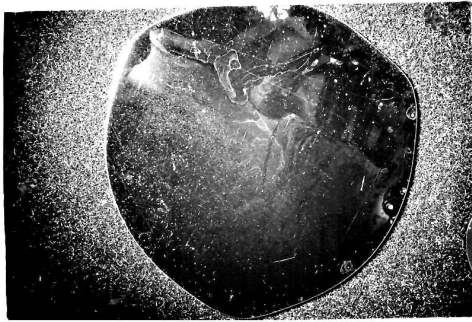
4,5 mm/min

First, a few optical pictures showing the swirl pattern on our 33 mm **FZ** crystals. The pulling speed is also indicated.

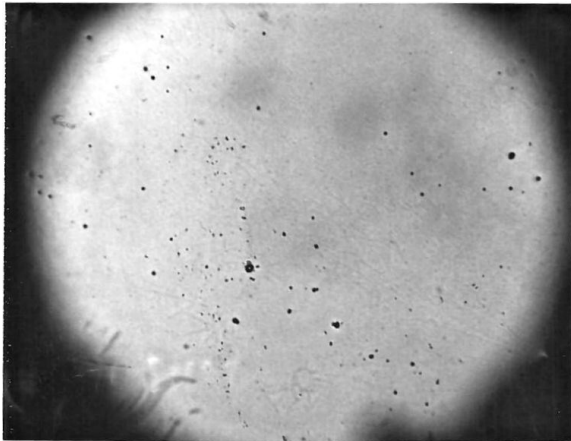
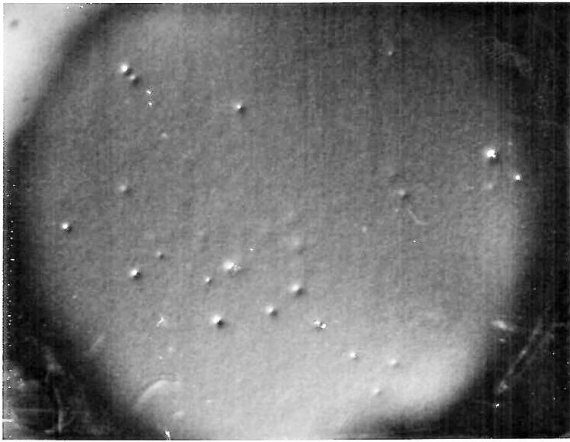
One more example to specimens preparation

**Top: 2.3 mm diameter specimen, through-light view**  
**Bottom: Looking at the surface**

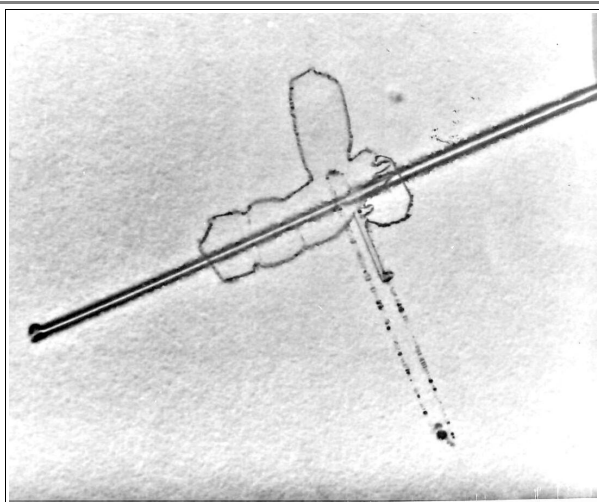
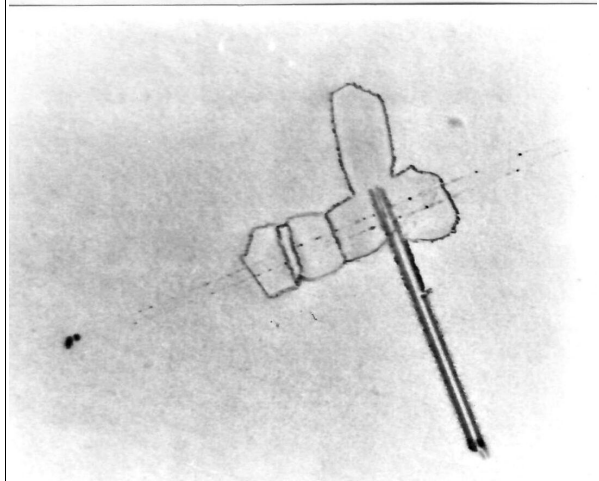
**Huge defect shown at two different diffraction conditions.**

Here, as in other examples, the very long and straight dislocations dipoles are decorated by second order agglomerates.

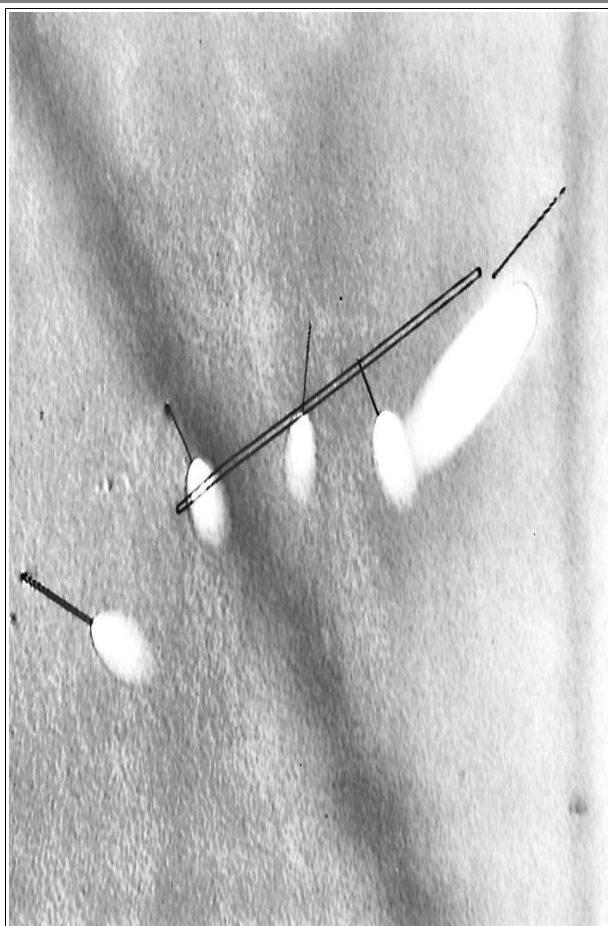
**A rather weird assembly**

Of course, the major part of this defect might have been etched out by specimen preparation, witness the etch pits.

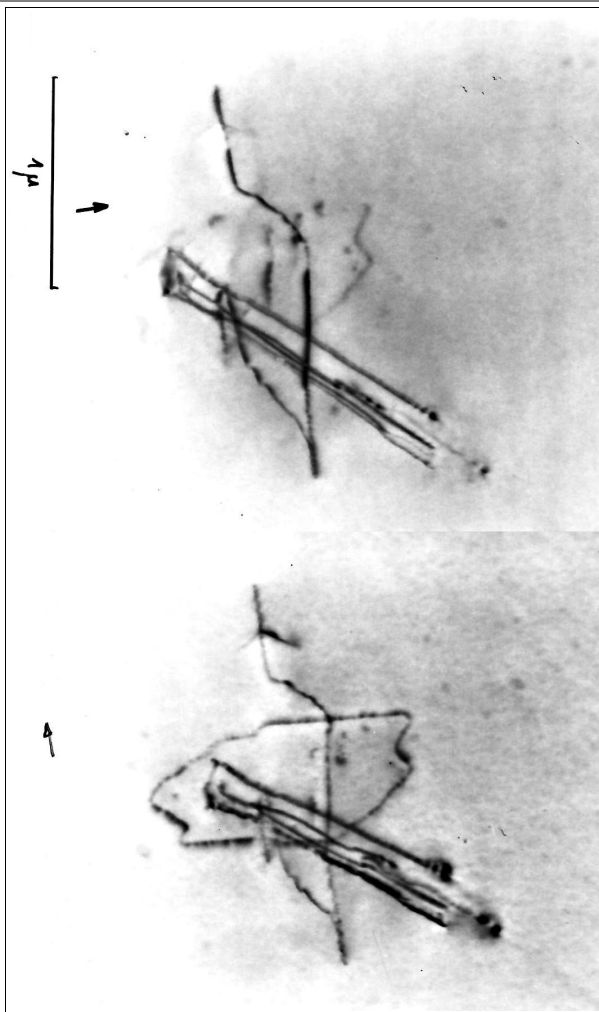
**Complex defect shown at two different diffraction conditions.**

A simple unfaulted loop seems to be at the heart of the defect..

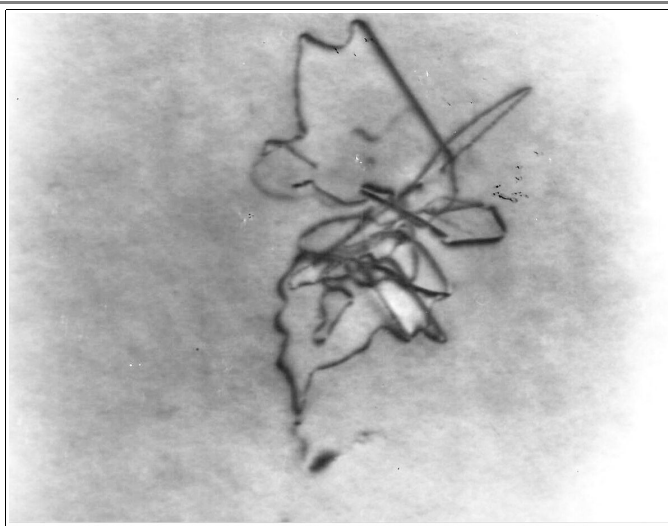
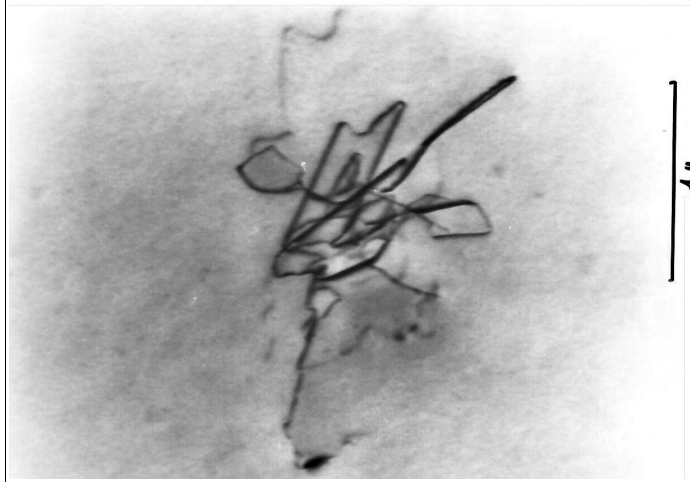
**Complex defect shown at two different diffraction conditions.**
