Pictures to: 3.1 TEM Work at Cornell University

3.1.1. TEM Investigations of Grain Boundaries in Silicon

Part 2: Fig. 9 - Fig. 16 plus some Auxiliaries

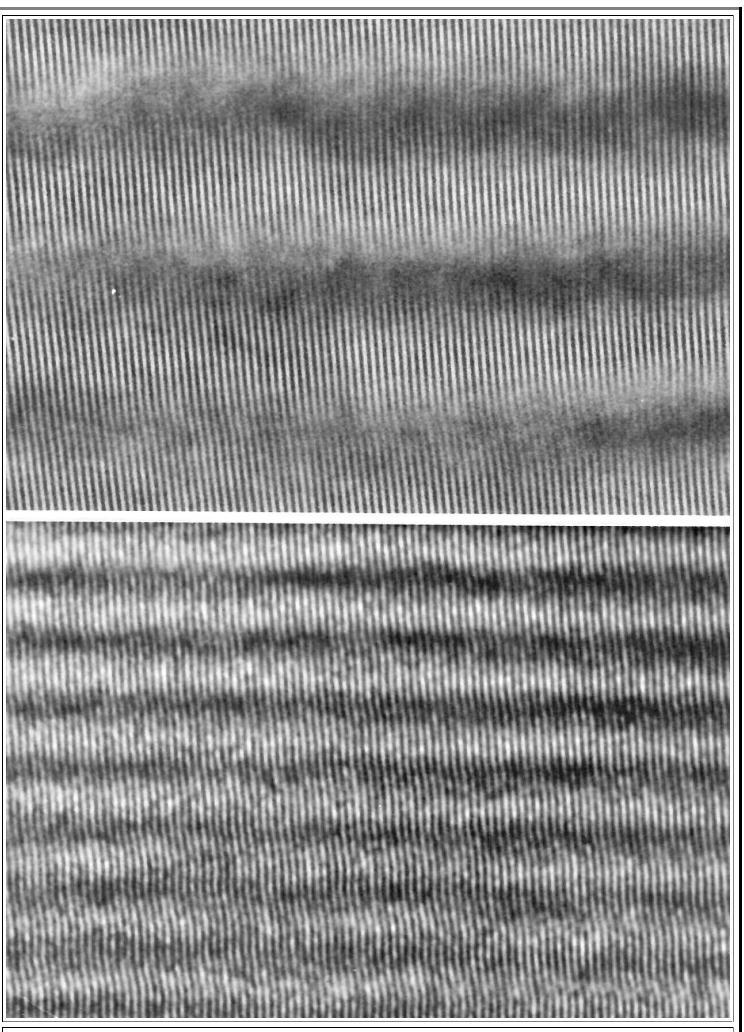
Fig. 9 in publication.

(111) lattice fringes across two low-angle boundaries on (100) planes. Tlted-beam illumination and a specimen orientation close to a (112) pole was used for this and the following lattice-fringe images. The spacing between the fringes is 0.31nm.

I fondly belie that this is the very first high-resolution TEM (*HRTEM*) picture of screw dislocations. It shows directly the typical drawings shown in text books

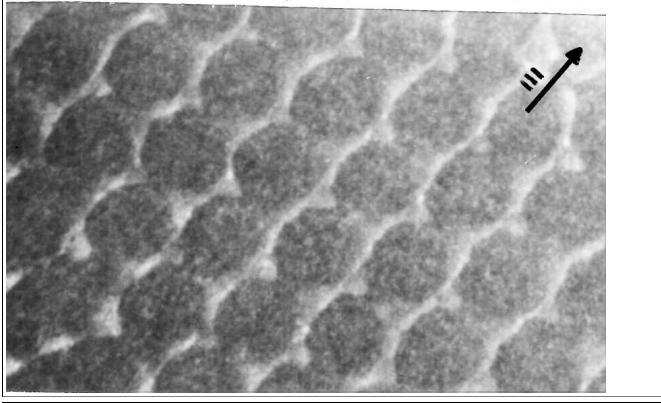
Relating to Fig. 10. Showing contrast change from intrinsic to extrinsic stacking fault upon changing the sign of the diffraction vector

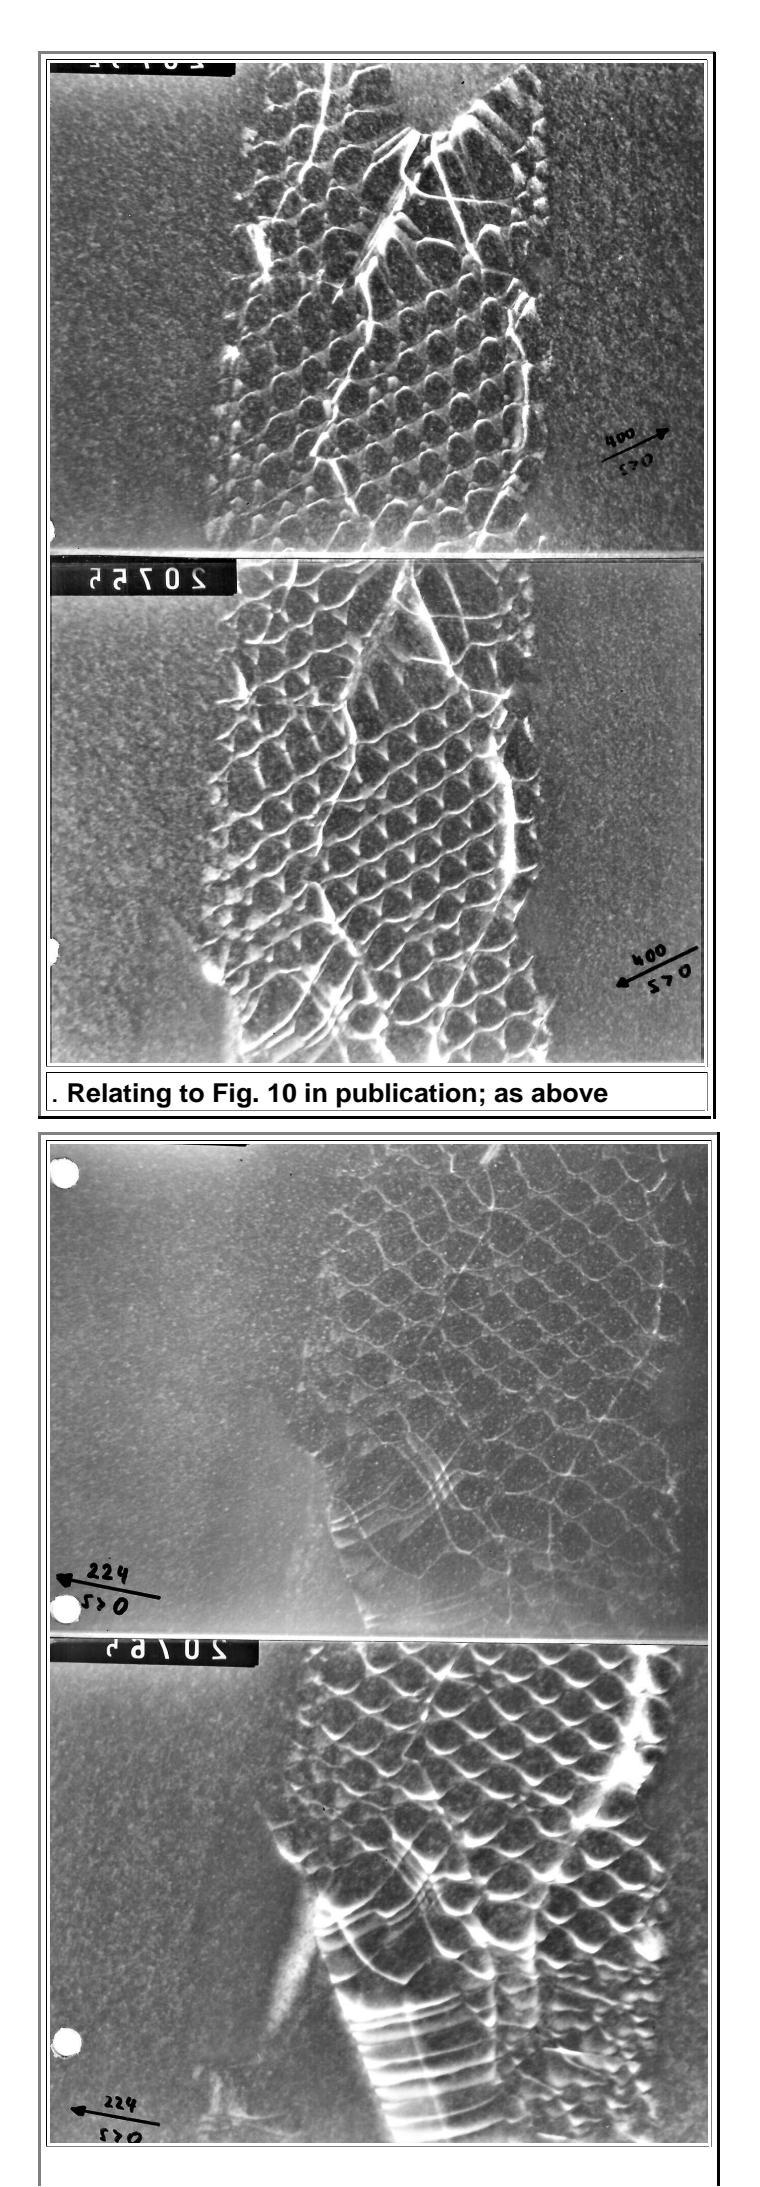
Auxiliary picture to Fig. 10. Increasing the excitation error in weak beam increases resolution but decreases contrast. It also needs longer exposure times and thus increases the risque of blurring

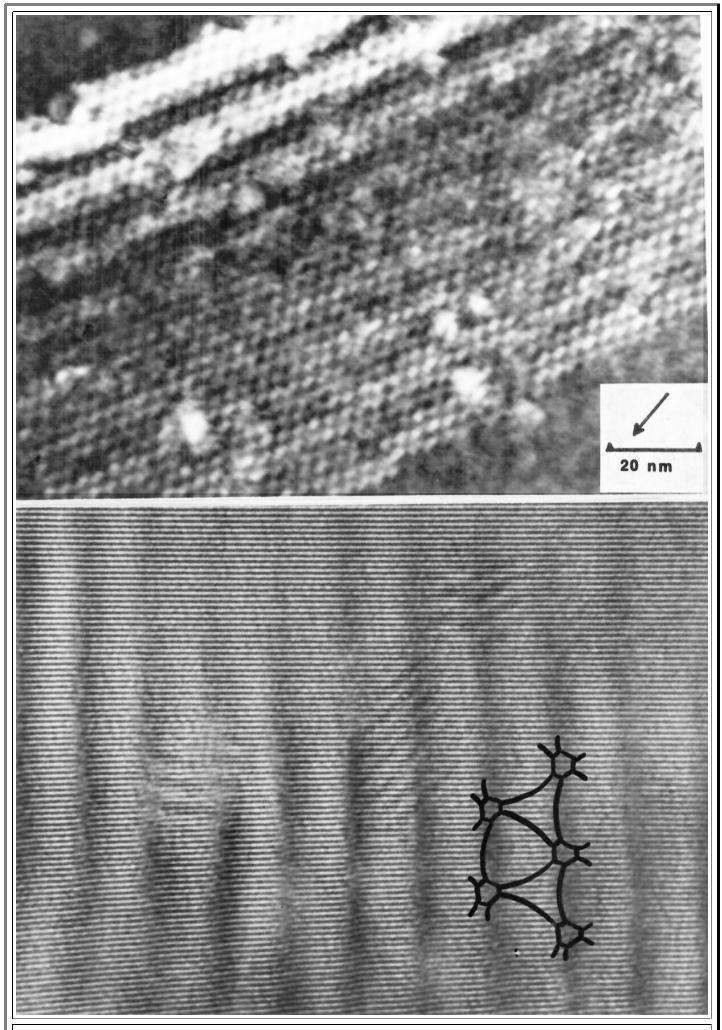
Fig. 11 in publication.

Weak-beam and lattice-fringe image of a low-angle twist boundary on a (111) plane.
